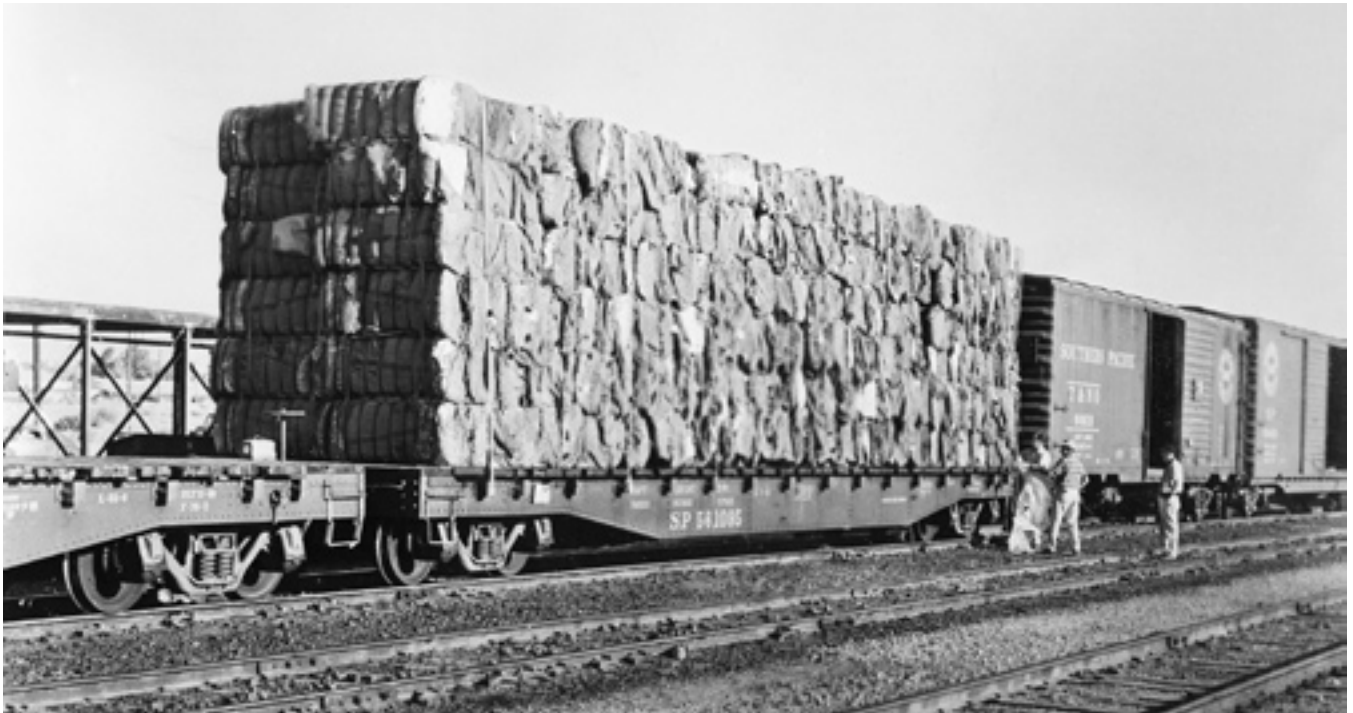
(Above) An experimental loading of Class F-70-7 no. 561095 with cotton bales from the California Cotton Company in 1961. Photographed at Bakersfield, California. (negative N-6268-1, Shasta Division Archives)

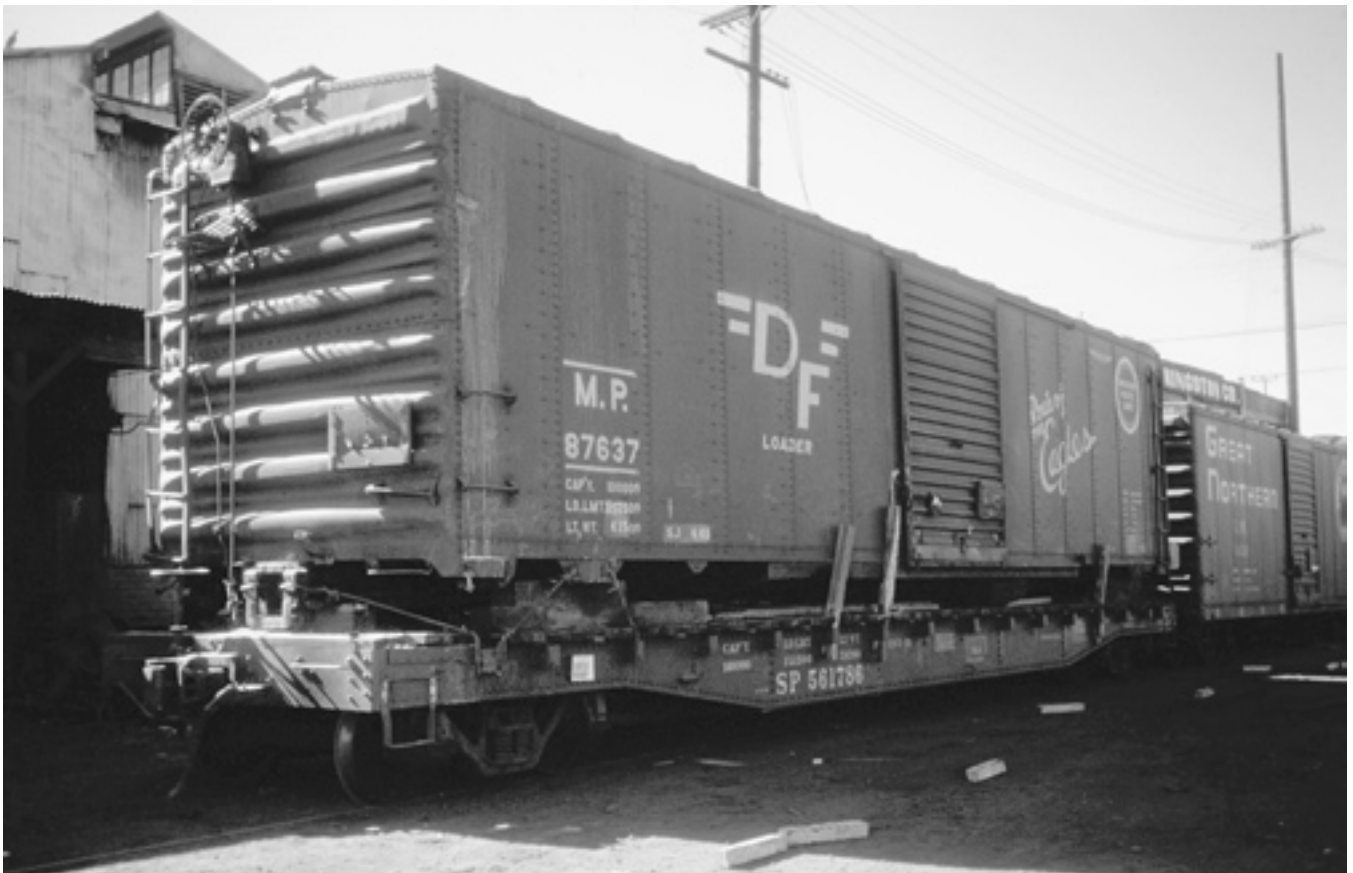
(Below) This Missouri Pacific box car has been in an accident and, no longer "Damage Free," is being shipped home on SP Class F-70-7 no. 561786. Photograph in September, 1961. (Howard Ameling)

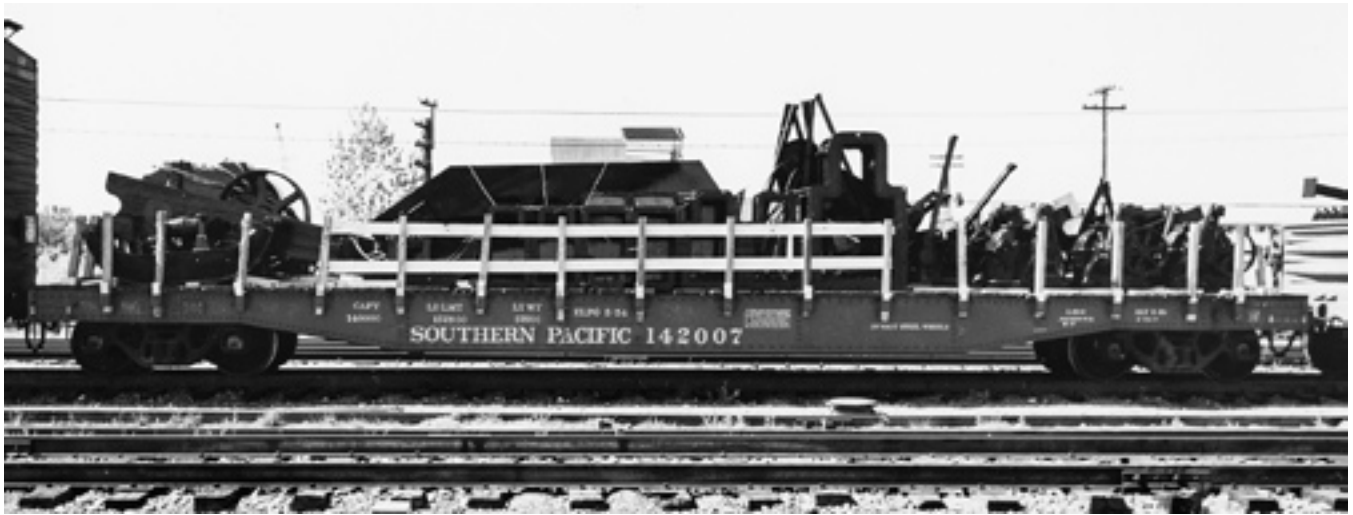
(Above) This load of machinery parts, noted on the photo as “mining equipment,” was photographed at Tucson, Arizona in September, 1955. Stakes and a few side boards restrain the load. Car no. 142007, Class F-70-7, has all its journal box lids open, perhaps in the process of car inspection prior to departure. (Shasta Division Archives)

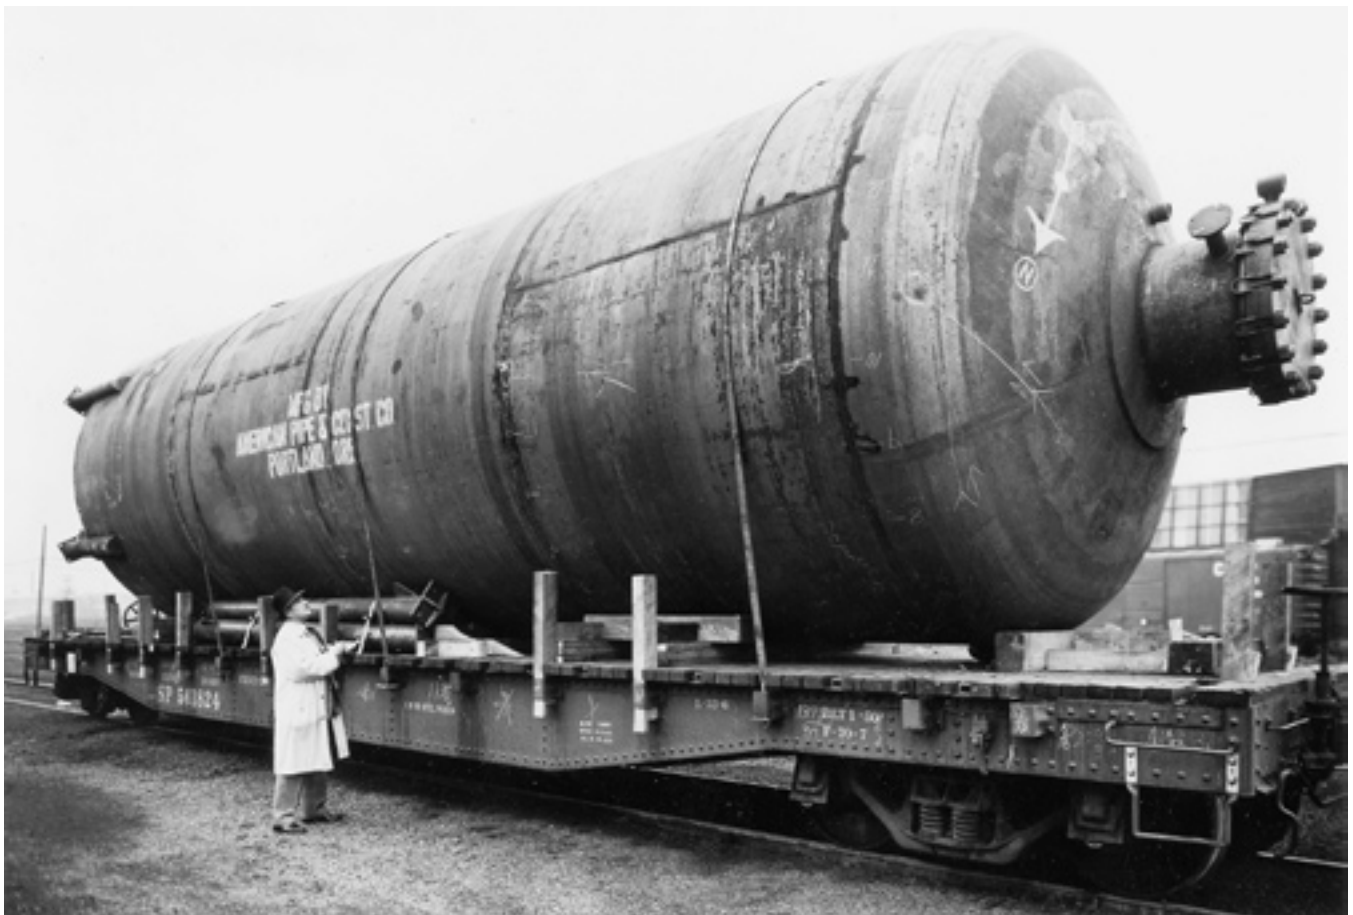
(Below) This large vessel for a chemical plant, produced by American Pipe & Construction Company of Portland, Oregon, is being shipped on Class F-70-7 car no. 561824 in this 1959 photo. Note how hold-downs with threaded ends pass through plates and tightened nuts underneath stake pockets. (Sheldon King collection)
